RESA REPORT

Property
2102 North 55th Street
Phoenix, AZ 85054

Prepared by: Bret Hunting.
RESA Job #: Sample Report
Inspection Date: December 9, 2008

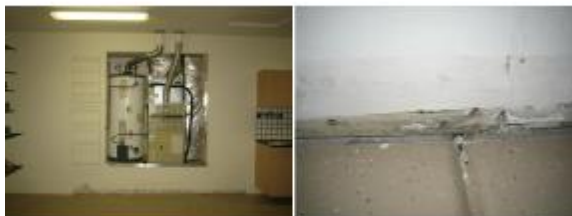
AREA: Garage Air Handler Area.

FINDINGS: Observed water staining and suspect mold like growth along the bottom of the drywall below the air handler unit. I also observed heavy rust staining in the plenum below the air handler unit. The stained wall surfaces were reading dry where checked with a non-penetrating moisture meter at the time of this inspection.

APPARENT CAUSE: Past leak from Air Handler.

RECOMMENDATIONS: I recommend either taking mold samples at this time or professional mold remediation by a certified remediation company.

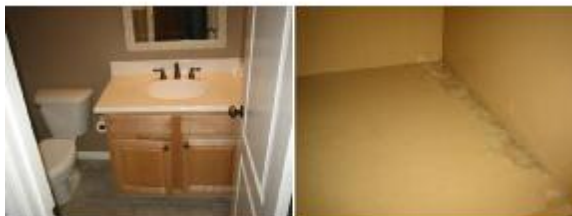
AREA: Hall Bathroom.

FINDINGS: Observed water staining and water damage at the bottom shelf and left side cabinet panel, also noted suspect mold like growth on the bottom shelf, below the sink. The cabinet and adjoining drywall were reading dry when checked with a non-penetrating moisture meter at this time.

APPARENT CAUSE: Leak from air handler in garage.

RECOMMENDATIONS: I recommend either taking mold samples at this time or professional mold remediation by a certified remediation company.

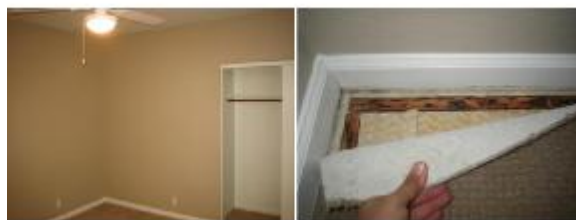
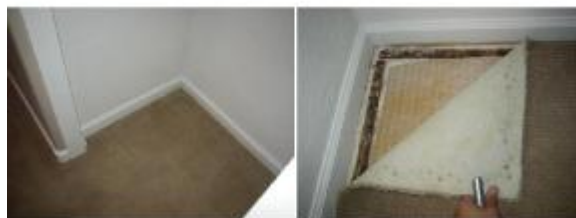
AREA: Lower S/E Bedroom.

FINDINGS: Observed water staining and suspect mold like growth on the base boards along the east and north bedroom walls. The base boards in the closet appear to have been replaced. The walls and base boards were reading dry where checked with a non-penetrating moisture meter at this time.

APPARENT CAUSE: Leak from air handler in garage.

RECOMMENDATIONS: The base boards in the N/W corner of the bedroom were not previously tested, client requested a sample be taken in the bedroom. Please see Mold Sample portion of this report.
